HOLE EXCAVATION #1 (on west side of Unit). Click the following link for the Plan of My Unit: [CLICK HERE](#). Note: 4 test holes were excavated next to my Unit's slab. See the above Plan for their locations (Drawn: 29th Oct. 2010 & updated 22nd April 2011)

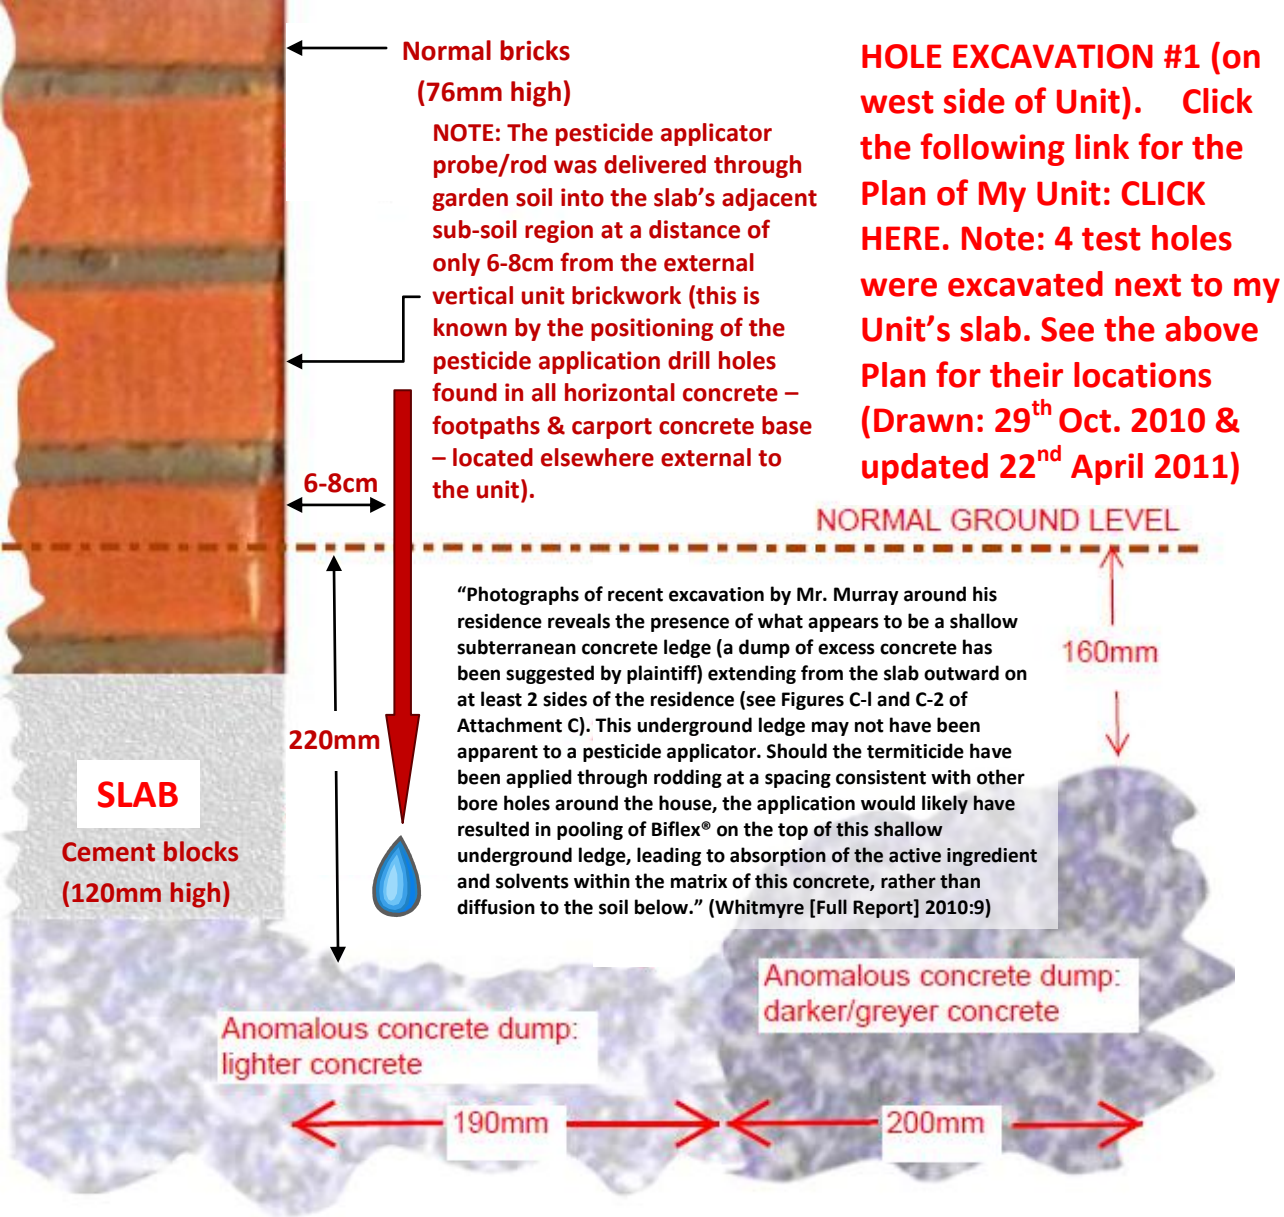
NOTE: The pesticide applicator probe/rod was delivered through garden soil into the slab's adjacent sub-soil region at a distance of only 6-8cm from the external vertical unit brickwork (this is known by the positioning of the pesticide application drill holes found in all horizontal concrete – footpaths & carport concrete base – located elsewhere external to the unit).

"Photographs of recent excavation by Mr. Murray around his residence reveals the presence of what appears to be a shallow subterranean concrete ledge (a dump of excess concrete has been suggested by plaintiff) extending from the slab outward on at least 2 sides of the residence (see Figures C-1 and C-2 of Attachment C). This underground ledge may not have been apparent to a pesticide applicator. Should the termiticide have been applied through rodding at a spacing consistent with other bore holes around the house, the application would likely have resulted in pooling of Biflex® on the top of this shallow underground ledge, leading to absorption of the active ingredient and solvents within the matrix of this concrete, rather than diffusion to the soil below." (Whitmyre [Full Report] 2010:9)

Anomalous concrete dump:
lighter concrete

Anomalous concrete dump:
darker/greyer concrete
